Extension FactSheet

Carpenter Bees

Susan C. Jones

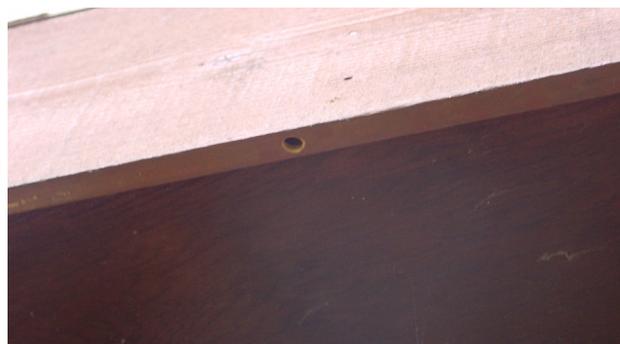
Figure 2. Carpenter bee entrance hole in fascia.

The carpenter bee entrance hole in wood may not necessarily be in an exposed area. For example, the inner lip of fascia boards is a common site of attack. Nail holes, exposed saw cuts, and unpainted wood are attractive sites for the bees to start their excavations.

Carpenter bees create a nuisance by excavating round entry holes in wood (Figure 2) and depositing yellowish to brownish streaks of excrement and pollen on surfaces below entry holes (Figure 3). They also produce coarse

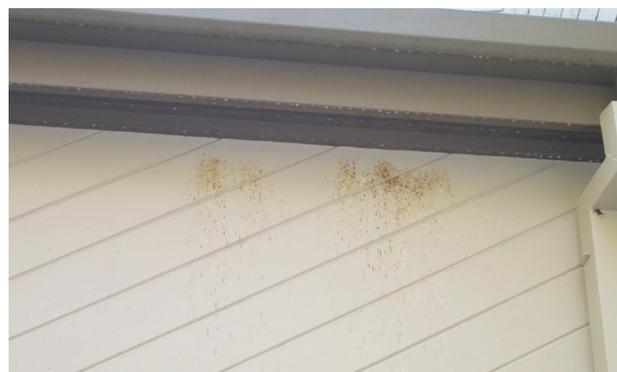
Figure 3. Carpenter bee staining on siding below the fascia.

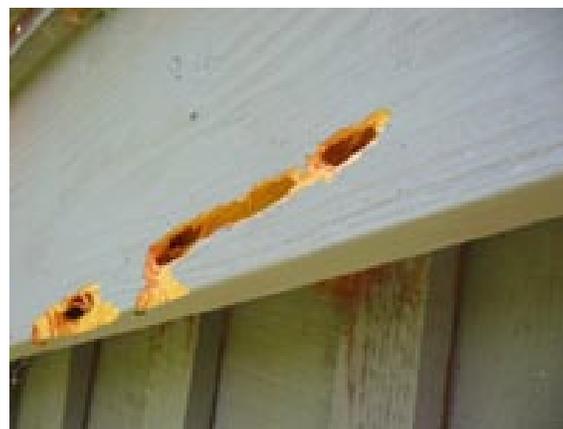
Figure 4. Carpenter bee gallery exposed in wood.

sawdust from their borings. The carpenter bee gallery system is confined within the wood (Figure 4) and hence is not visible.

Carpenter bee damage to wood initially is minor, and carpenter bees seldom cause consequential structural damage. However, their repeated colonization of the same wood can eventually cause considerable wood damage. Carpenter bees preferentially refurbish and enlarge an existing tunnel instead of boring a new one, and a gallery can extend for 10 feet if used by many carpenter bees over the years.
